Inspection Report

Ridge Valley Home Inspections

Date: 26/09/2013	Time: 3:00 PM	Report ID
Property:	Customer:	Real Estate Professional:

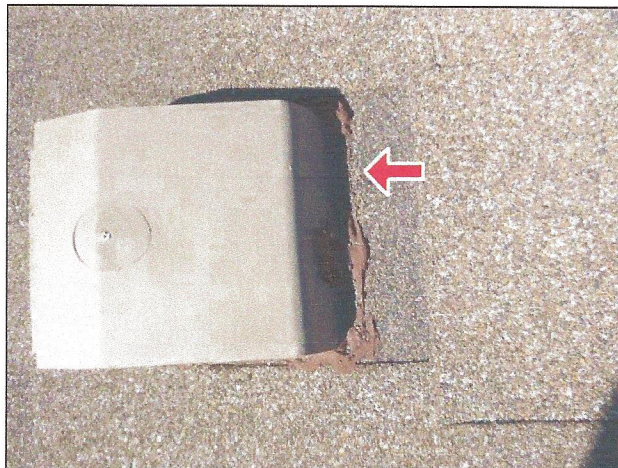
1.1 Item 1(Picture)

- 1.1 Improve caulking.

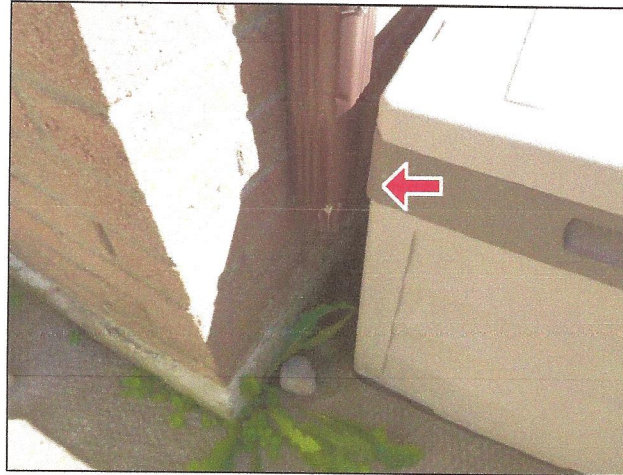
1.3 Item 1(Picture)

1.3 (1) Downspouts require extensions which direct the roof water well away from the foundation. Recommend install as needed.

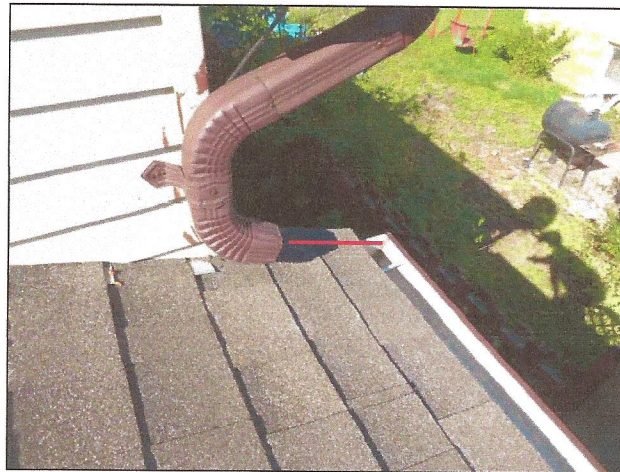
1.3 Item 2(Picture)

1.3 (2) The upper level eave trough drains directly onto lower roof covering. Recommend adding a down spout extension to the the lower roof eave trough to reduce localized roof wear.

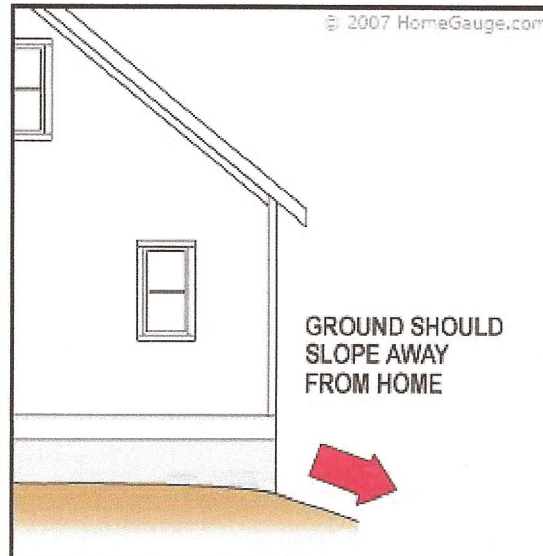
2.0 Item 1(Picture)

**2.0 (1)** There is a negative slope evident at the left side at the patio. This may not facilitate proper drainage and may allow water to accumulate next to the foundation, which may contribute to dampness or in the worse case, leakage into the basement. Recommend that the grade be modified to slope away from the house.

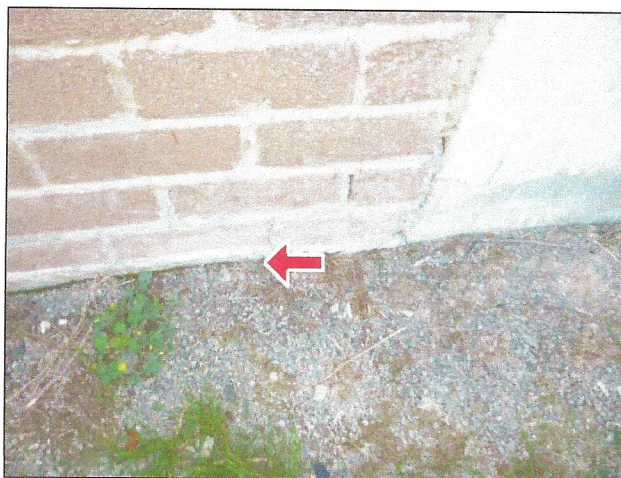
2.0 Item 2(Picture)

🏠 (2) Grade is very close to the lower course of brick. Recommend improve to minimize the potential of water entry.

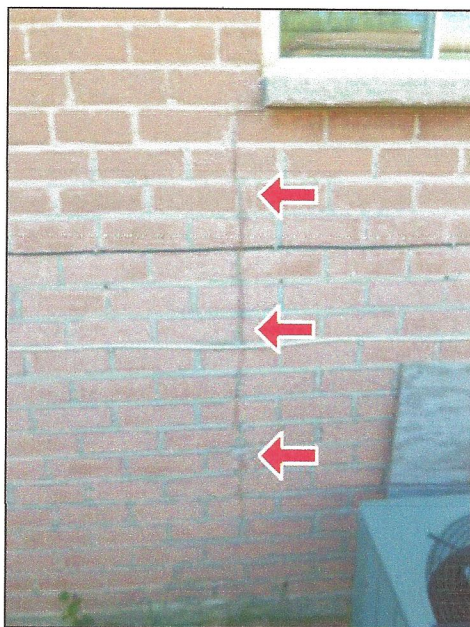
2.2 Item 1(Picture)

🏠 2.2 Masonry cracks between brick and cracked brick. This is an indication of slight settlement or movement. Recommend monitor for further movement. Repair as required.

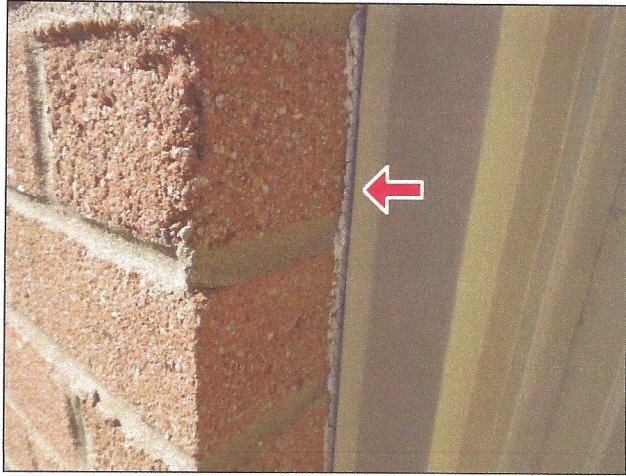
2.3 Item 1(Picture)

🏠 2.3 (1) Exterior siding and trim requires painting.

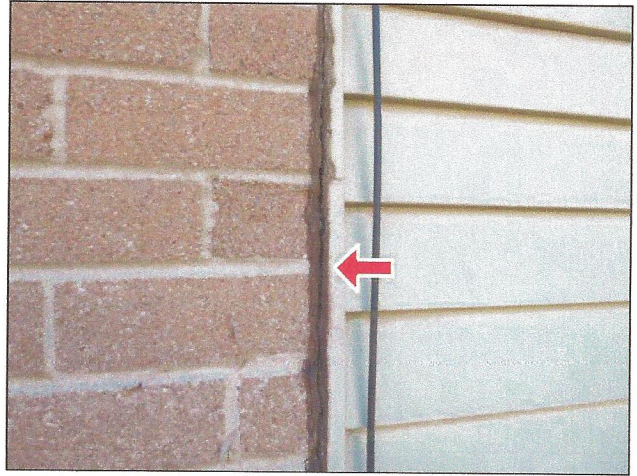
2.3 Item 2(Picture)

🏠 (2) Exterior Caulking Required in various areas throughout the exterior.

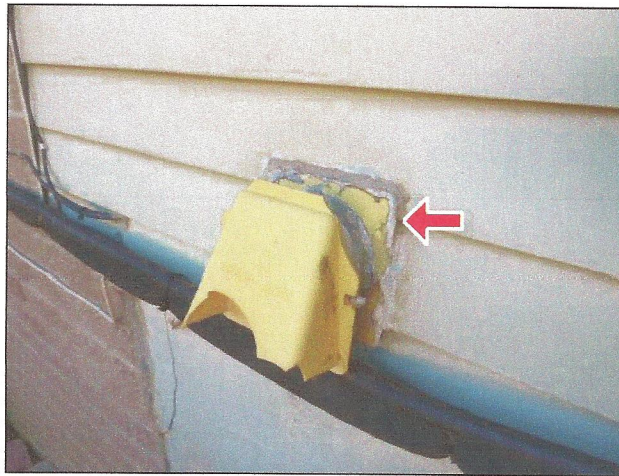
2.3 Item 3(Picture)

🏠 (3) Recommend seal all wall penetrations (pipes, vents etc...)

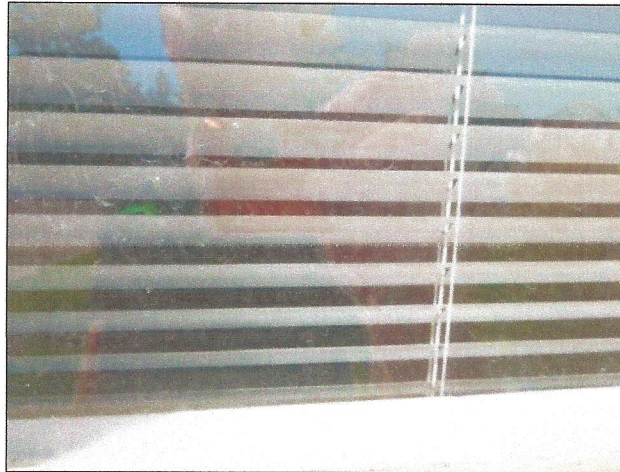
2.6 Item 1(Picture)

2.6 (1) Fogging of the insulated glass unit(s) is evident at the living Room window(s). This fogging effect is caused by a leak in the thermal seal between the panes of glass. Although this may result in a slightly lower thermal resistance it is mainly a cosmetic concern. In cold weather the fogging effect may worsen considerably. If you consider the appearance of the "fogging" unacceptable it will be necessary to replace the glass unit or the window in its entirety.

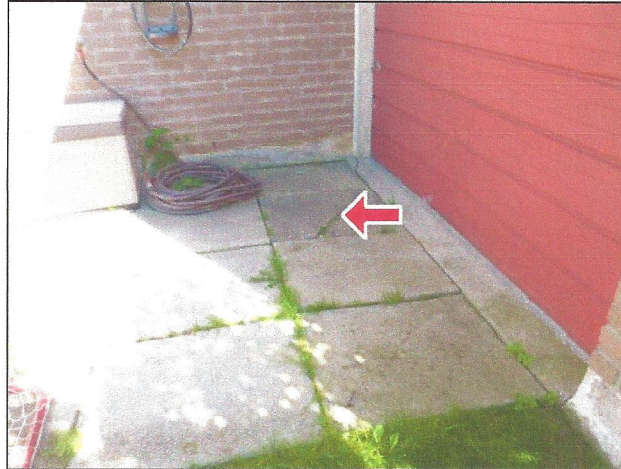
2.7 Item 1(Picture)

🏠 2.7 (1) The concrete walk has settled and slopes towards the house which will allow water to pool next to the foundation. Recommend corrective action to prevent moisture related problems.

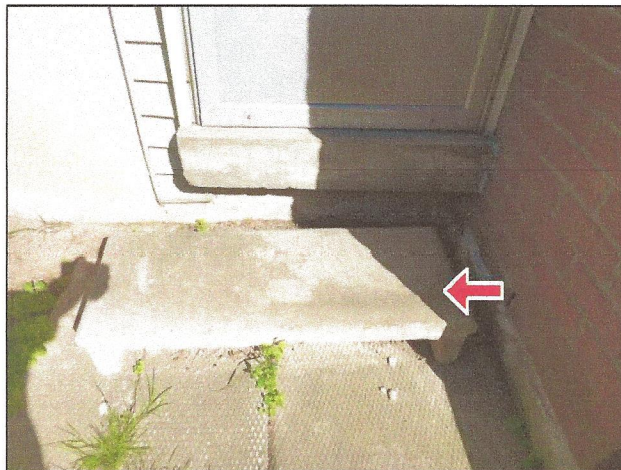
2.7 Item 2(Picture)

🏠 (2) Settlement has caused step to become uneven. Recommend improvement this is a trip hazard.

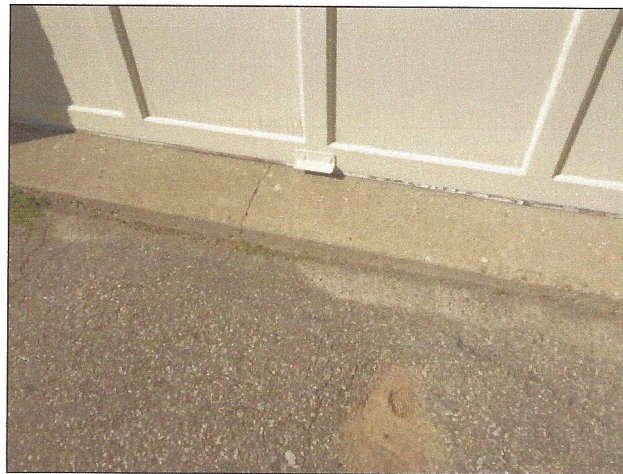
2.10 Item 1(Picture)

2.10 Note: Asphalt settlement noted on wheel tracks of driveway.

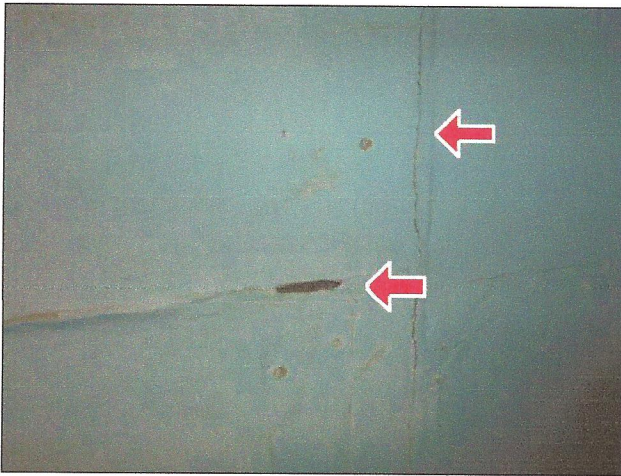
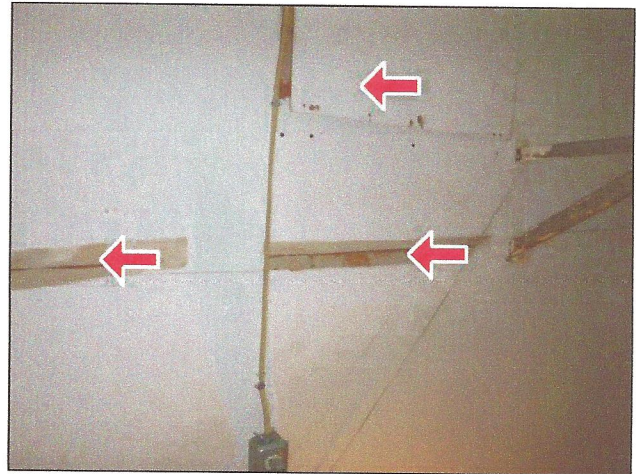
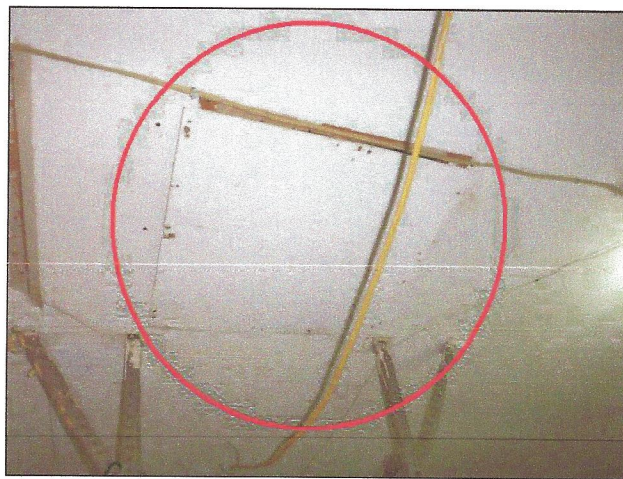
3.0 Holes noted in the walls and or ceiling of the garage (Including the attic access hatch), recommend that they be sealed to prevent the migration of fumes /gases into the house.

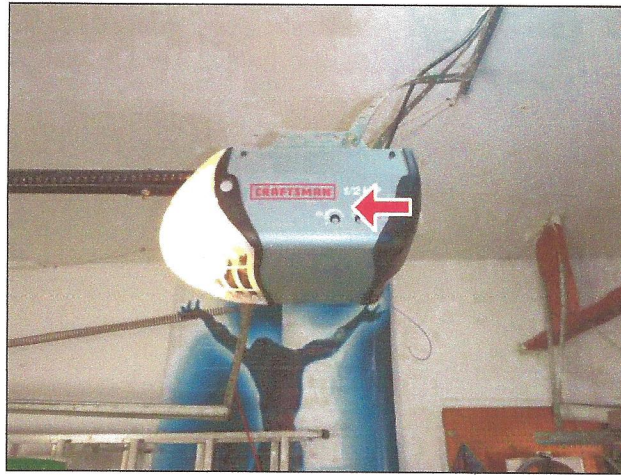
3.3 Item 1(Picture)

3.3 The garage door opener should automatically reverse when the door is met with resistance. When tested, an excessive amount of resistance was required to reverse the door. This is considered a crush Hazard. The automatic door opener requires a simple adjustment as per the manufacturers specifications to eliminate the crush hazard.

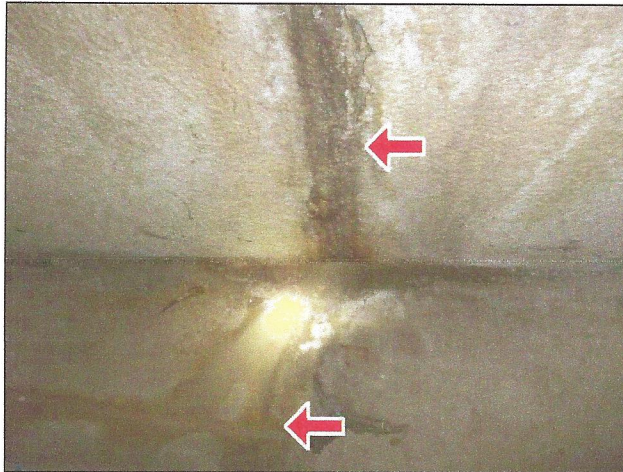
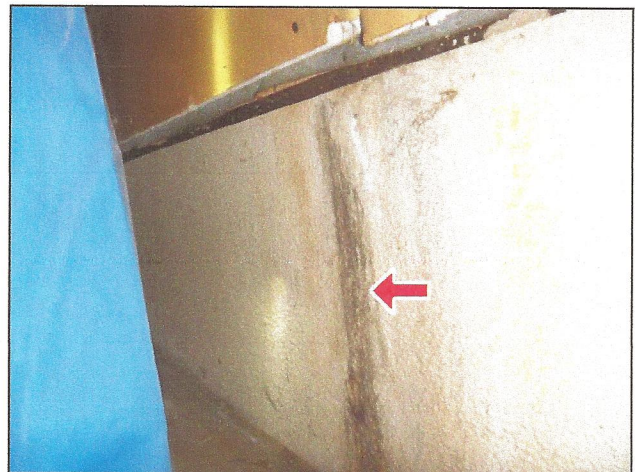
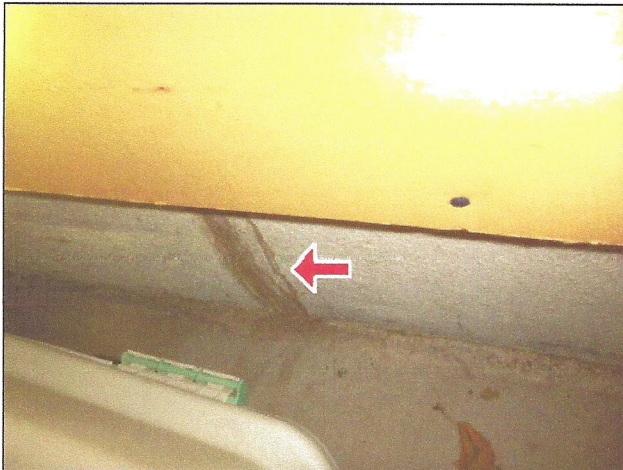
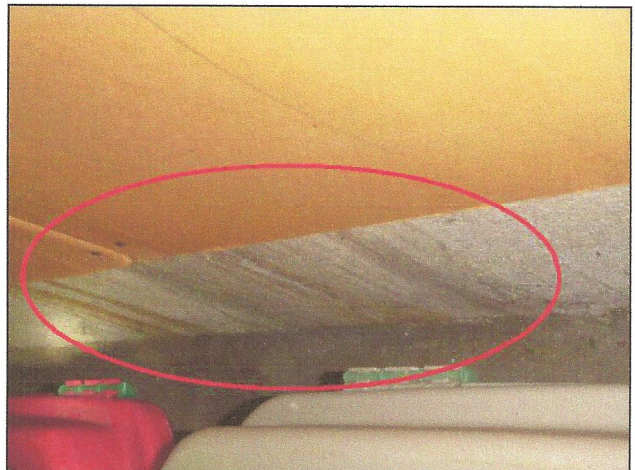
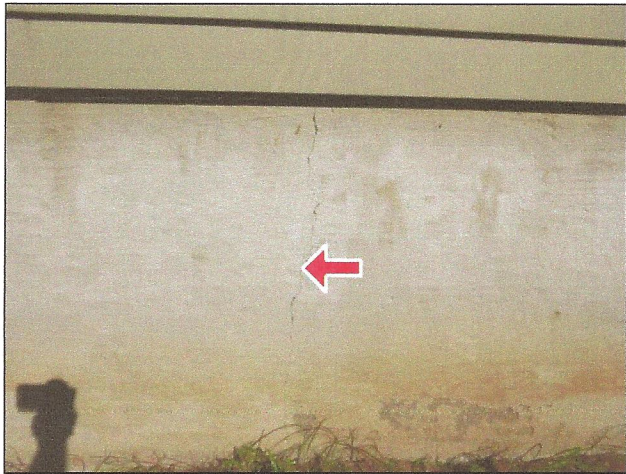
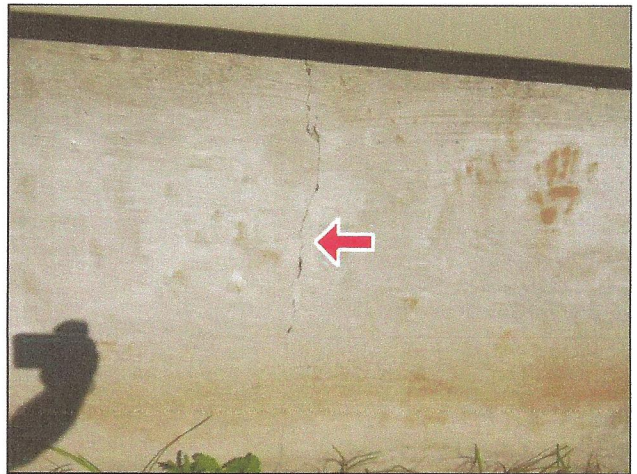
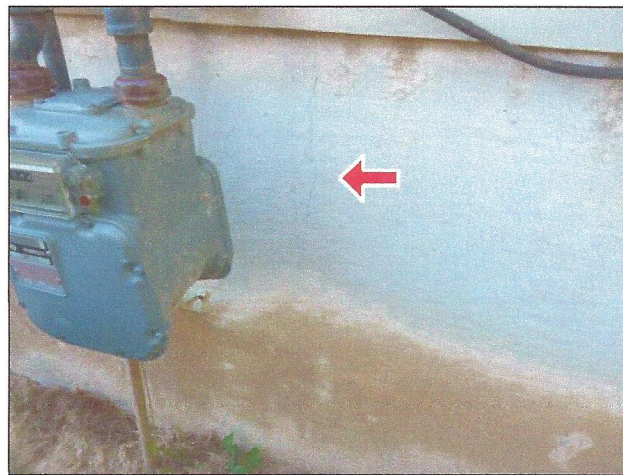
**4.0** (1) Typical Foundation cracks were observed. All cracks have a potential to allow the entry of ground water under certain circumstances, however a large percentage of foundation cracks are not problematic. There were no visible signs of ground water seepage at the time of the inspection. Recommend monitor.

🏠 (2) Visible signs of water intrusion in the crawl space are present from water stains on the wall and floor. Water intrusion if not corrected can lead to other problems including mold and cause excessive moisture to floor system that can lead to deterioration and increased repair cost.. I recommend further investigation or correction by a qualified licensed contractor or water infiltration specialist.

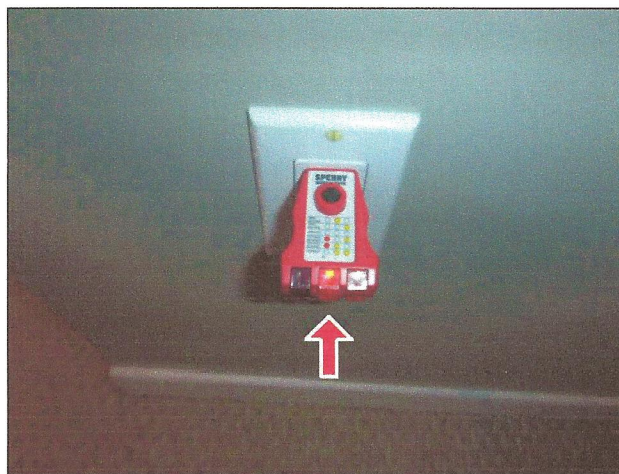
5.4 Item 1(Picture)

5.4 Ungrounded 3 prong outlets were noted in the Lower level living area and bathroom. Three prong outlets must not be used in ungrounded circuits as they pose a shock hazard. Where 3 prong receptacles are necessary I recommend adding a ground wire which may involve extensive rewiring or alternatively ground fault circuit interrupters (GFCI receptacles) may be installed. Although GFCI's are considered an acceptable alternative in this situation they do have their limitations and should not be used with surge protection devices, as the lack of a ground reference prevents proper surge protection. Recommend all repairs and or modifications be done by a licensed electrician.

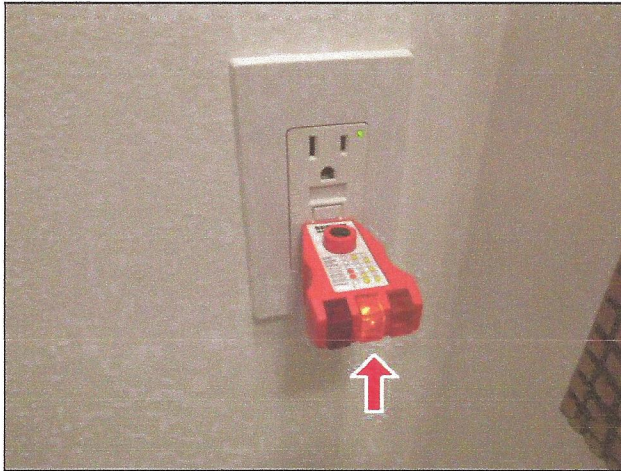
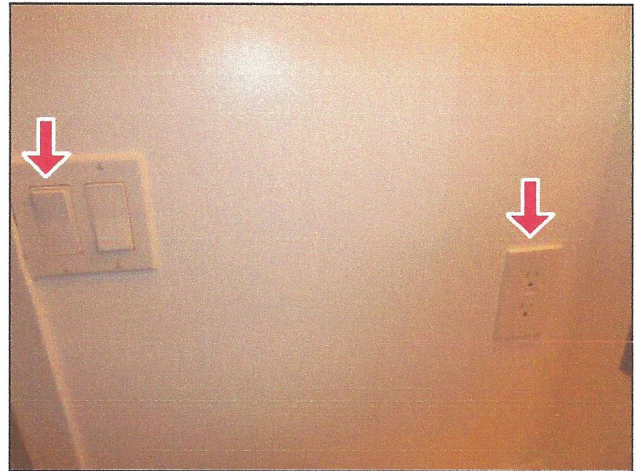
5.5 (2) The GFCI in the lower level bathroom is miswired. There is no ground present and on two occasions when the light was turned off the GFCI tripped. Recommend repair by a qualified electrician.

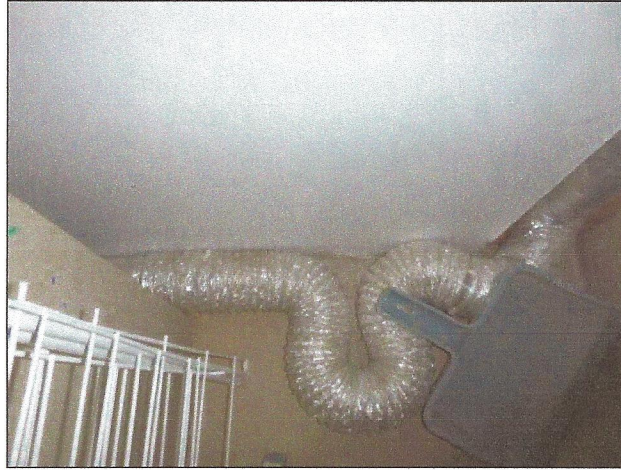
6.4 Item 1(Picture)

📍 6.4 (1) The length of the dryer vent is excessive and may affect the overall performance of the dryer.

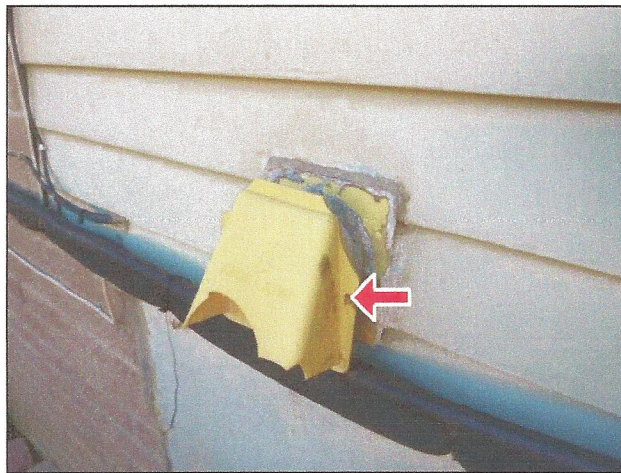
6.4 Item 2(Picture)

📍 (2) Exterior wall vent requires repair/ replacement.

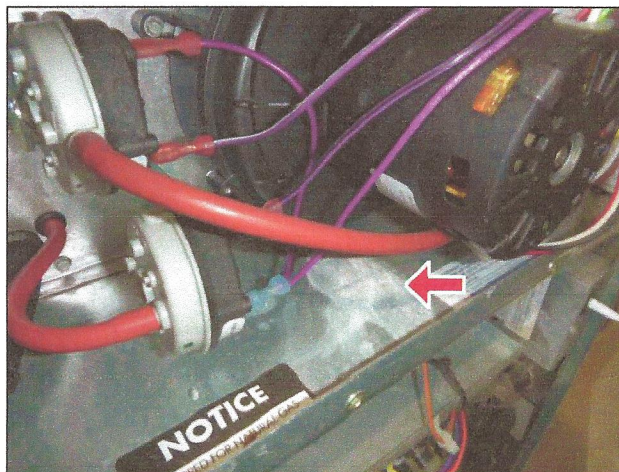
7.0 Item 1(Picture)

↑ (2) Water marks located beneath the exhaust blower are indicative of previous condensate leakage. Recommend monitor during regular operation to determine if leakage is current. Repair as required.

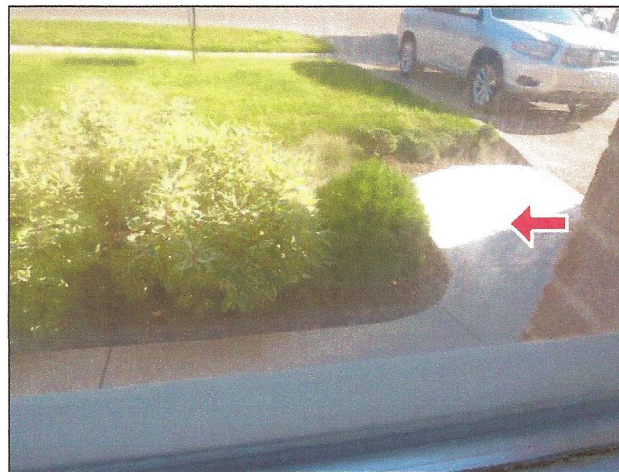
9.2 Item 1(Picture)

**9.2 (1)** Fogging of the insulated glass unit(s) is evident at the living Room window(s). This fogging effect is caused by a leak in the thermal seal between the panes of glass. Although this may result in a slightly lower thermal resistance it is mainly a cosmetic concern. In cold weather the fogging effect may worsen considerably. If you consider the appearance of the "fogging" unacceptable it will be necessary to replace the glass unit or the window in its entirety.

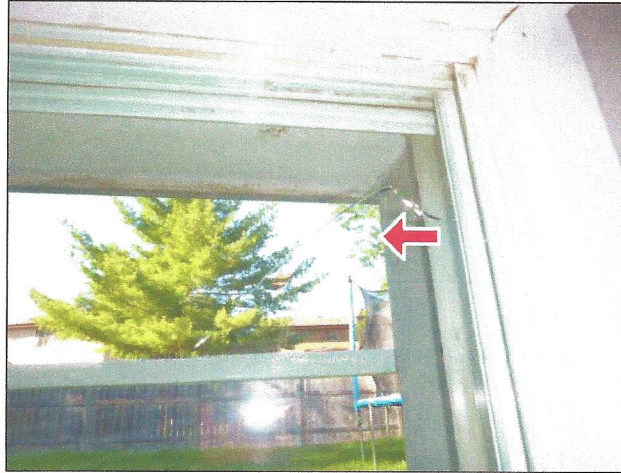
9.2 Item 2(Picture)

🏠 (2) There are cracked glass in some windows throughout home.

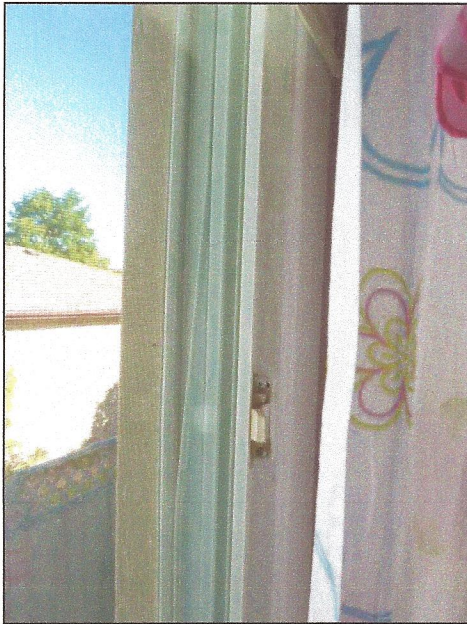
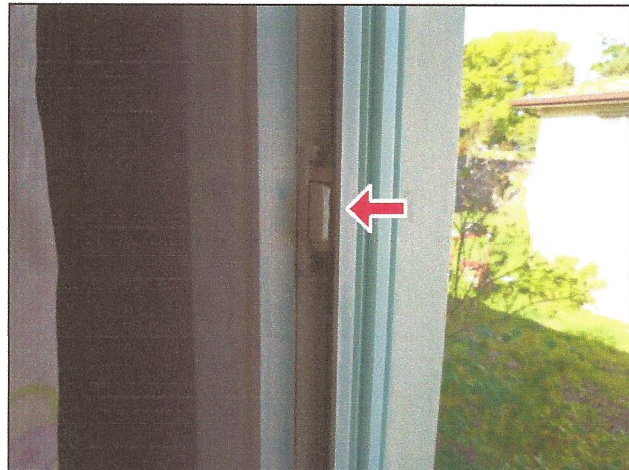
🏠 (3) The operating mechanism for the window located in the front bedroom is not functional. Repair or replacement is necessary.

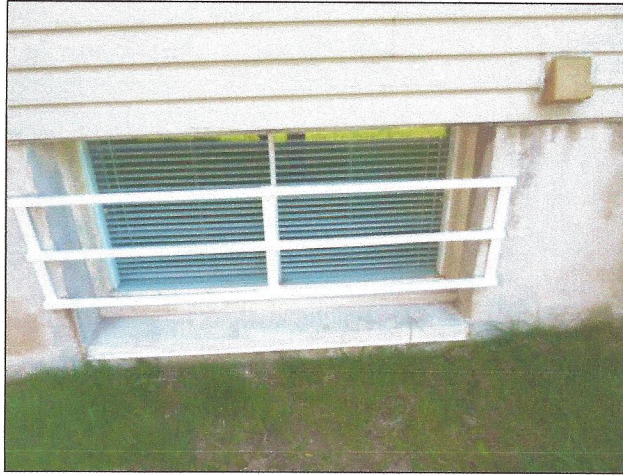
9.4 Item 1(Picture)

**9.4** The bars on the basement windows should be removed if the basement bedroom will be used as a bedroom.

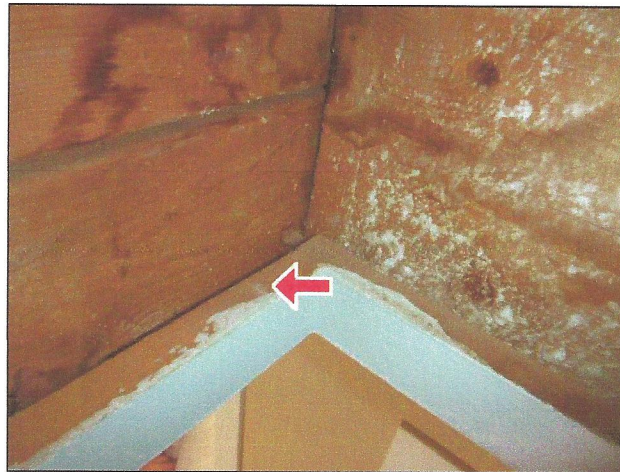
12.0 Item 1(Picture)

- 📌 **12.0** Recommend install weather stripping around the attic hatch to prevent air leakage into the attic space.
